# Preliminary Analysis Report

Bryson v. Rough Country, LLC Mecanica Case Number: 22-3104 Date of Collision: March 15, 2020

Report Date: March 27, 2024

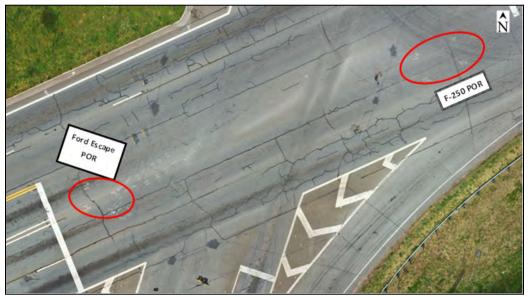
**Figure 2** is an orthomosaic created from drone aerial photographs of the site showing a close-up of the intersection. In the orthomosaic (**Figure 3**) the police markings indicating the rest positions of the vehicles were observed. From the SCRT Report, the F-250 was moved after it originally came to rest. The police report identified the collision site as 25 feet east of Blue Ridge Drive on Georgia 2.

Figure 3: GDPS aerial view with points of rest marked

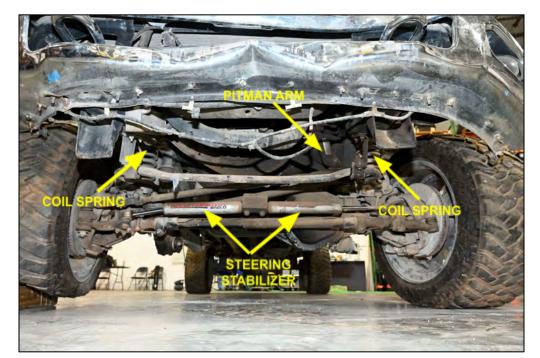
The aftermarket lift kit from Rough Country was installed on the F-250 before this incident. The kit included coil springs, radius arm drop brackets, sway-bar drop brackets, track bar drop brackets, stabilizer relocation brackets, pitman arm, brake lines, brake line brackets, shock absorbers, bump stop spacers, lift blocks, U-bolts, and attachment hardware (Figures 4 and 5). In addition, the pickup had a steering stabilizer and larger tires and wheels than original equipment.

Figure 4: Front underbody of F-250 showing various aftermarket components

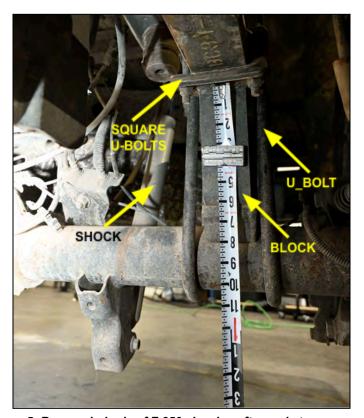
Figure 5: Rear underbody of F-250 showing aftermarket components

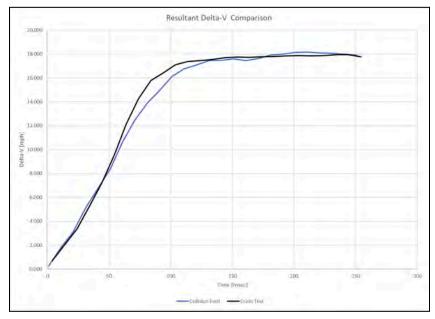
Table 1 contains a comparison of vehicle impact speeds and delta-Vs for the crash and the test that was conducted.

Figure 29: Resultant delta-V comparison between crash test and collision F-250.

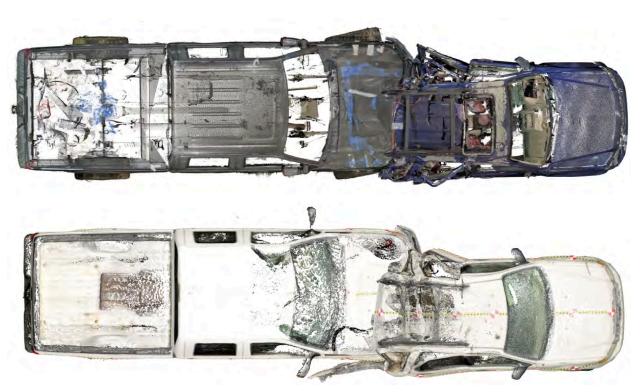
**Figure 39** shows the alignment comparison of the subject vehicles and that achieved for the test vehicles at maximum static crush. Based on the analyses and crash test performed, the deformation and accelerations of the Escape would have been substantially similar whether the F-250 was lifted or was equipped with a stock suspension. Vehicle outlines were then placed over the vehicle point clouds and the point clouds were then removed (**Figure 40**). The dimension was then measured from the front bumper of the F-250 to the front bumper of the Escape. This dimension was 10.6 feet and 9.9 feet for the subject vehicles and the test vehicles, respectively. This means the crash test had more intrusion than the subject vehicle from the crash.

Figure 39: Alignment comparison of subject vehicles (top) and test vehicles (bottom) at maximum mutual crush.

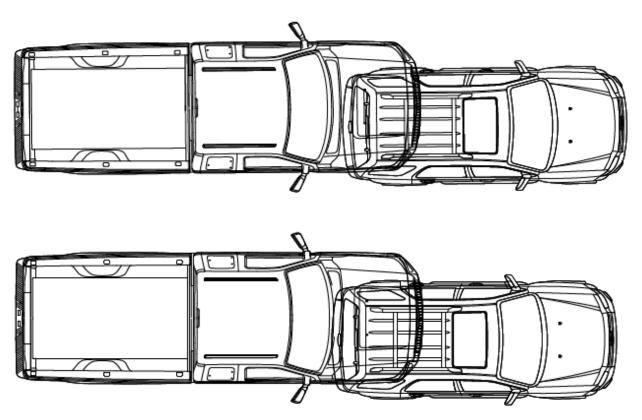
Figure 40: Alignment comparison with vehicle outlines of subject vehicles (top) and test vehicles (bottom) at maximum mutual crush.
